NPIC/CSD-138/66
11 MARCH 1966
PAGE 6

HIGHWAY BRIDGE
DIEN BIEN PHU, NORTH VIETNAM
2123N 10301E

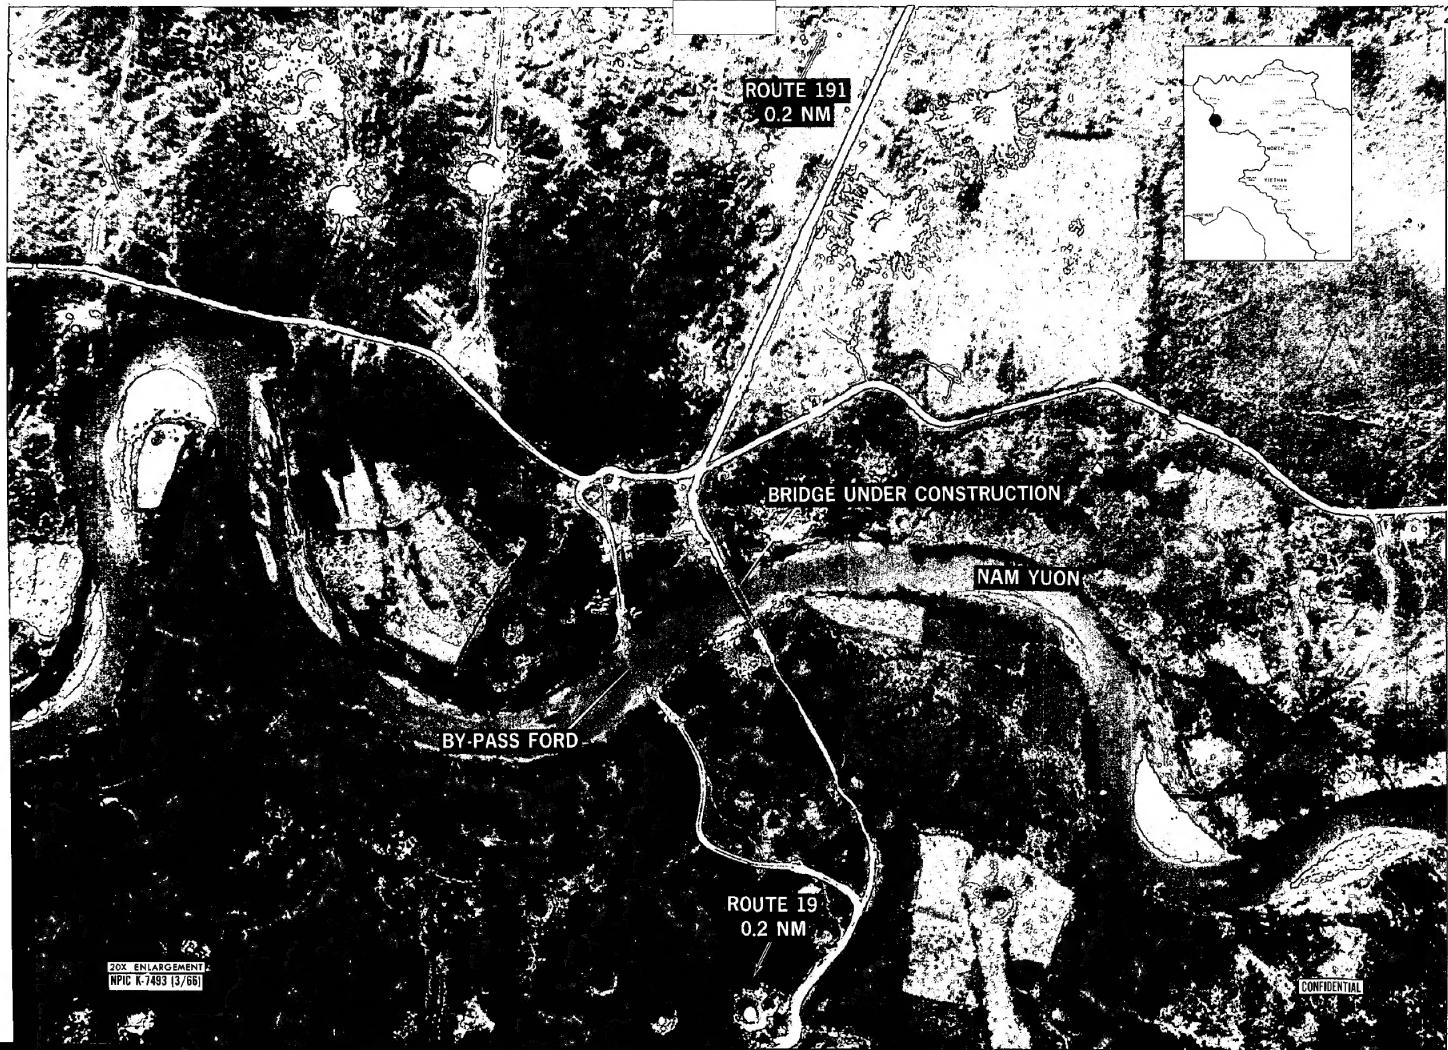
**HIGHWAY BRIDGE
DIEN BIEN PHU, NORTH VIETNAM
21-23N 103-01E**

THE PHOTOGRAPHY REVEALS A PROBABLY UNSERVICEABLE HIGHWAY BRIDGE LOCATED ON THE NORTH EDGE OF DIEN BIEN PHU, BETWEEN ROUTES 19 AND 191, OVER THE NAM YOUN (RIVER) AND A SERVICEABLE BY-PASS ON THE SOUTH SIDE OF THE BRIDGE SITE.

[REDACTED] REVEALS APPARENT CONSTRUCTION ON THE PROBABLY UNSERVICEABLE DIEN BIEN PHU HIGHWAY BRIDGE OVER THE NAM YOUN (RIVER). A SERVICEABLE BY-PASS FORD IS OBSERVED IMMEDIATELY TO THE SOUTH OF THE BRIDGE. NUMEROUS OLD AND A FEW NEW BOMB CRATERS ARE OBSERVED IN THE VICINITY OF THE BRIDGE.
